**CHARLES RIVER BASIN  
WESTON, MASSACHUSETTS**

**WESTON RESERVOIR DAM  
MA 00798**

**PHASE I INSPECTION REPORT  
NATIONAL DAM INSPECTION PROGRAM**

**FEBRUARY 1980**

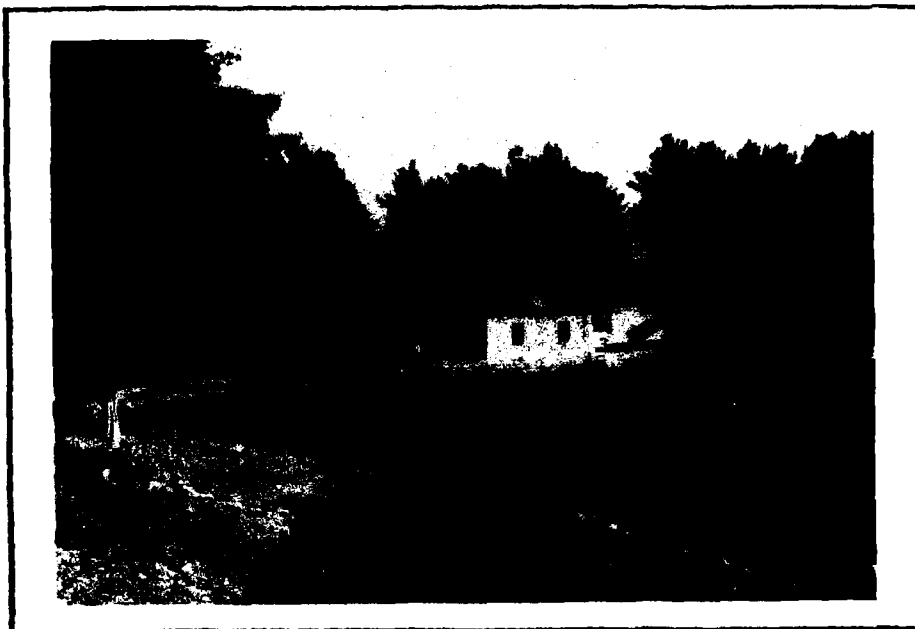
UPSTREAM OVERVIEW OF WESTON RESERVOIR DAM AS VIEWED FROM THE LEFT ABUTMENT. (10/23/79)

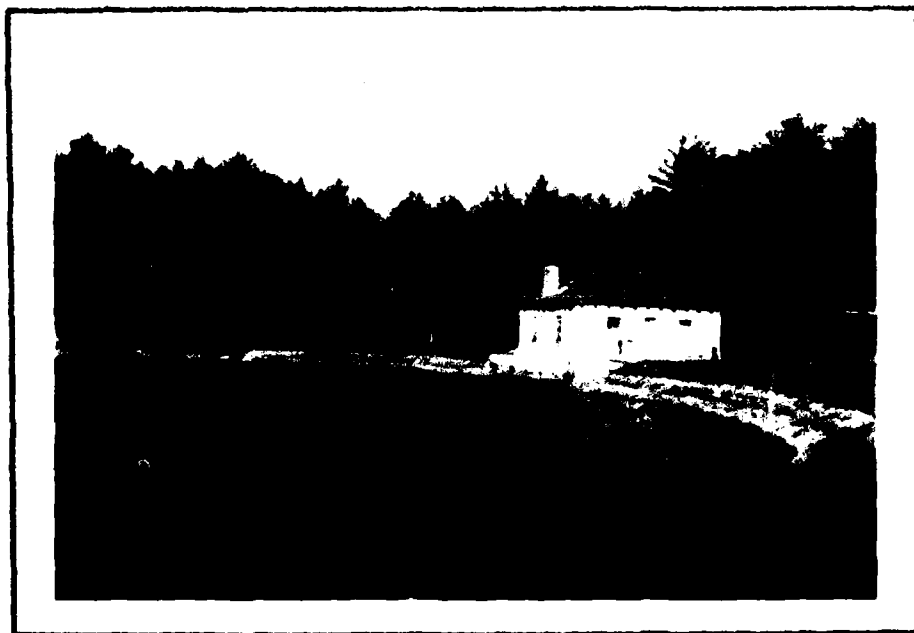
UPSTREAM OVERVIEW OF WESTON RESERVOIR DAM AS VIEWED FROM THE RIGHT ABUTMENT. (10/23/79)

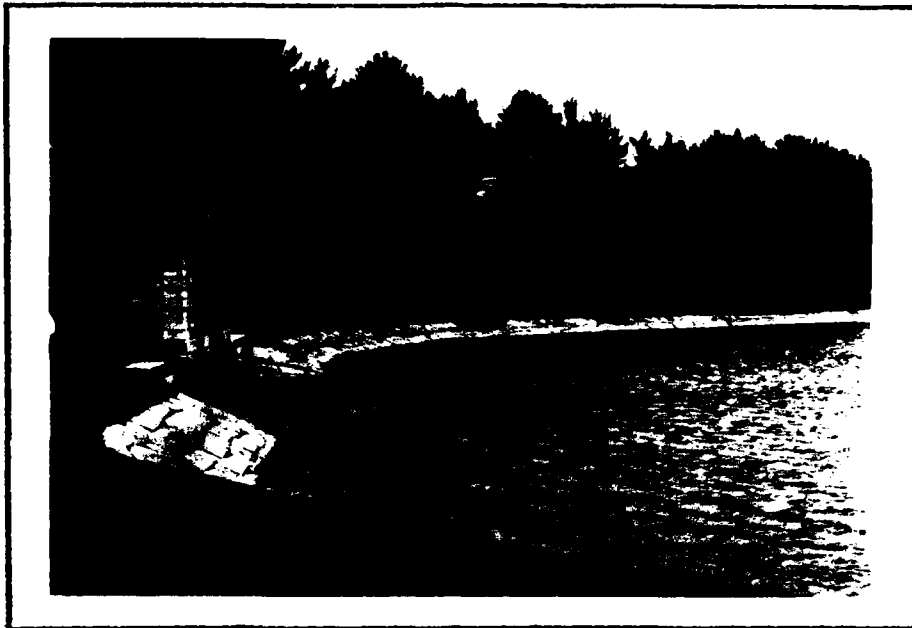
1. GATEHOUSE AND UPSTREAM SLOPE. (10/23/79)

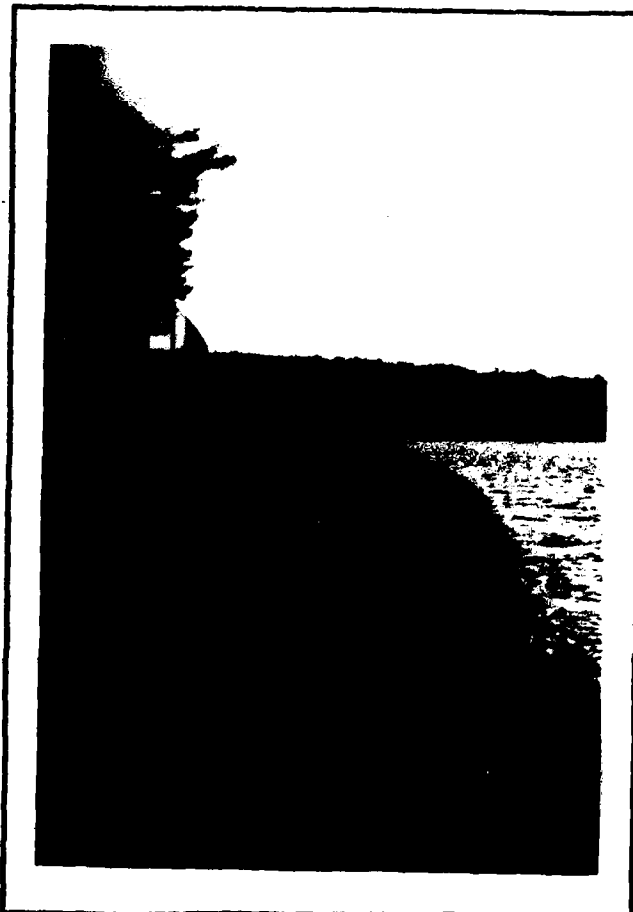
4. RIPRAP ON UPSTREAM SLOPE,  
GRASS COVER AND LARGE TREES  
ON THE DAM. (10/23/79)

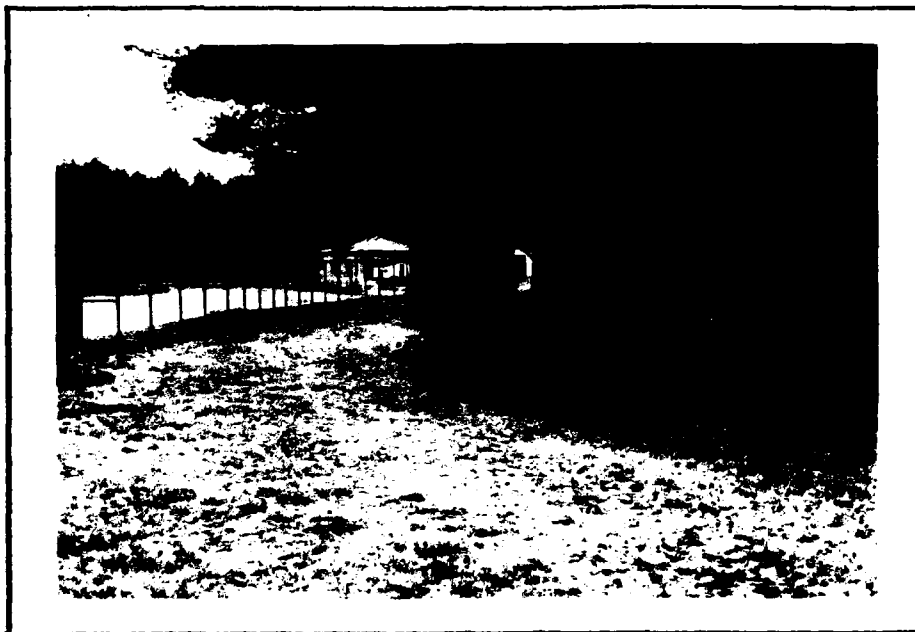
At the time of inspection, no signs of settlement, cracking, or other structural movement were observed. The upstream face and crest of the dam are well maintained and appeared to be in good condition. The downstream face of the embankment and a portion of the dam crest are partially obscured by a heavy growth of trees, brush and forest litter; therefore, it is difficult to tell if the downstream face of the dam and the crest are free of structural deficiencies. The root systems of the trees create a potential hazard to the integrity of the embankment. Severe winds could uproot some of the trees, thereby dislodging portions of the embankment in the process. The root systems of the trees could also create seepage paths through the dam.

5. CLOSE UP OF LARGE TREES GROWING ON THE DAM CREST AND DOWNSTREAM SLOPE. (10/23/79)

1. Perform a detailed hydrologic and hydraulic study to assess the need for providing spillway discharge capacity.
2. Investigate the cause of the seepage within a few feet of the downstream toe of the embankment along the right bank of the stream bypass outlet channel and assess the need for remedial action.
3. Investigate the seismic stability of the dam utilizing conventional equivalent static load methods.
4. Direct the removal of the trees from the downstream face (to a distance of 20 feet downstream of the toe) and crest of the dam to minimize damage to the embankment. Voids left in the embankment by the removal of trees should be filled with suitable, thoroughly compacted material.
